# 1 Introduction

This report aims to provide a comprehensive comparison of ultrasound and CT scan techniques to quantify and visualize calcium leaching in asbestos cement pipes. Through an analysis of the strengths and limitations of each method, we seek to offer valuable insights into their applicability and effectiveness in assessing the condition and remaining service life of asbestos cement pipelines.

Three DN100 asbestos cement pipes have been selected as samples for this test. The following procedure has been followed to obtain the necessary results for the comparison:

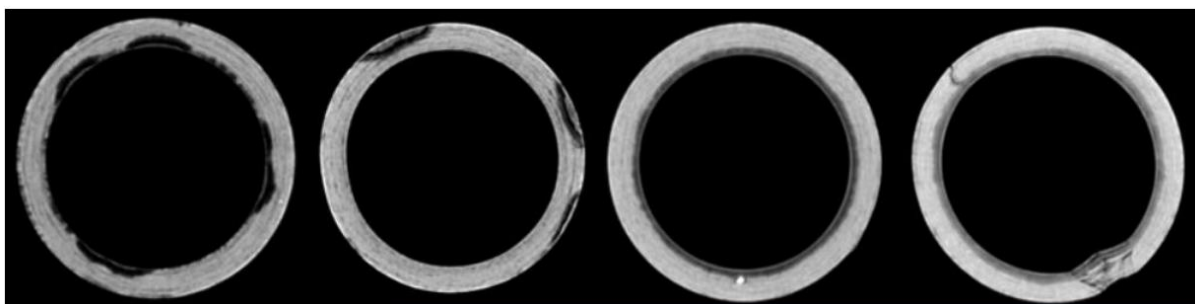
Typical CT scan results are slices along the longitudinal axis of the pipe as shown in Figure 1. Based on the measured intensity, these slices are converted to unaffected wall thickness. The wall thickness can then be mapped as function of circumferential and longitudinal position on the pipe. An example is shown in Figure 2.

Figure 1 CT scan slices

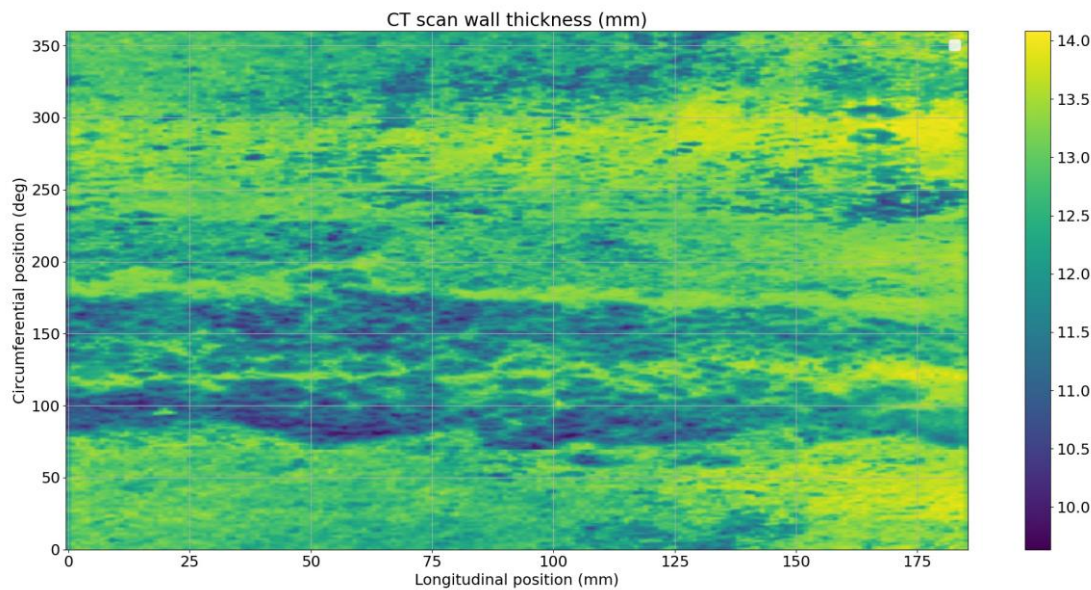
Figure 2 CT scan unaffected wall thickness heat map

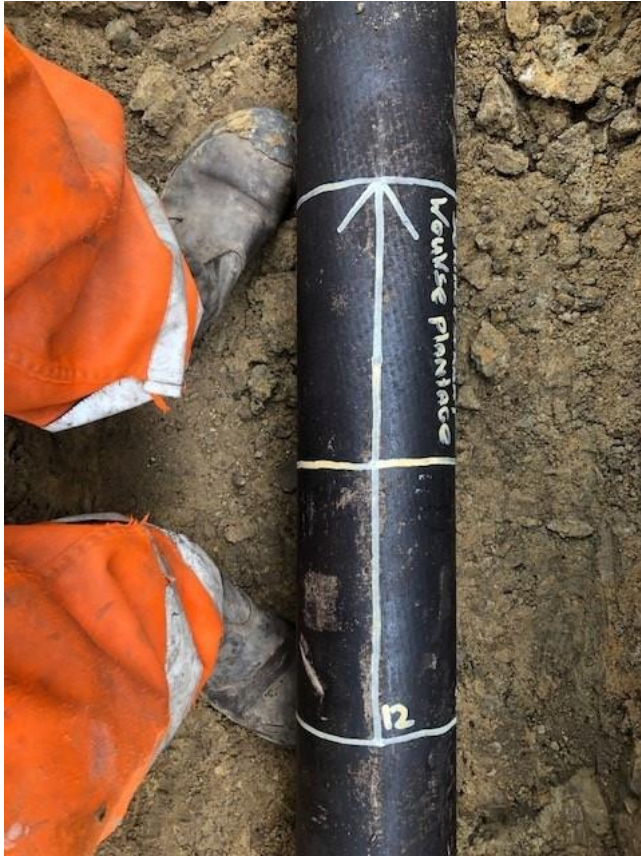
For each sample, the ultrasound measurements have been carried out using a couple of longitudinal lines on the pipe and a line on the circumferential of the pipe in field, while the pipes were still operational.

Figure 3 a field measurement using ultrasound

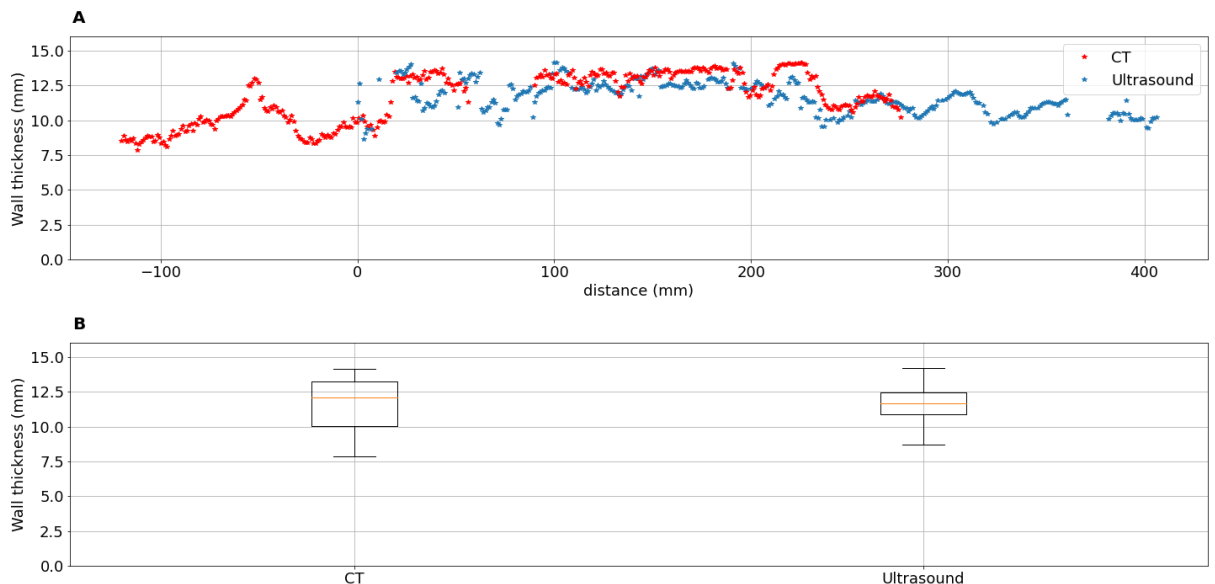
Figure 5 Sample 1, longitudinal scan 2

In order to compare the result of CT scan research with the results of ultrasound measurements, the scanned lines from the ultrasound measurements have been extracted from the heatmap of the CT scan. IN the following paragraphs, the direct comparison of the samples are shown. At the end of this chapter (paragraph 3.2) the results are discussed.

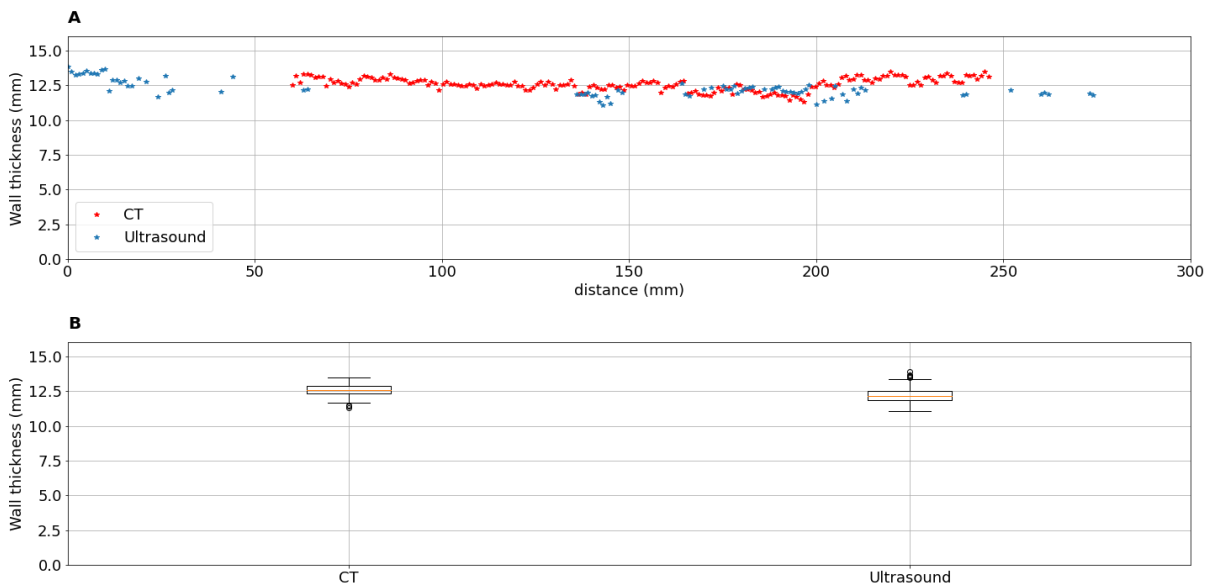
Figure 7 Sample 2, longitudinal scan 1

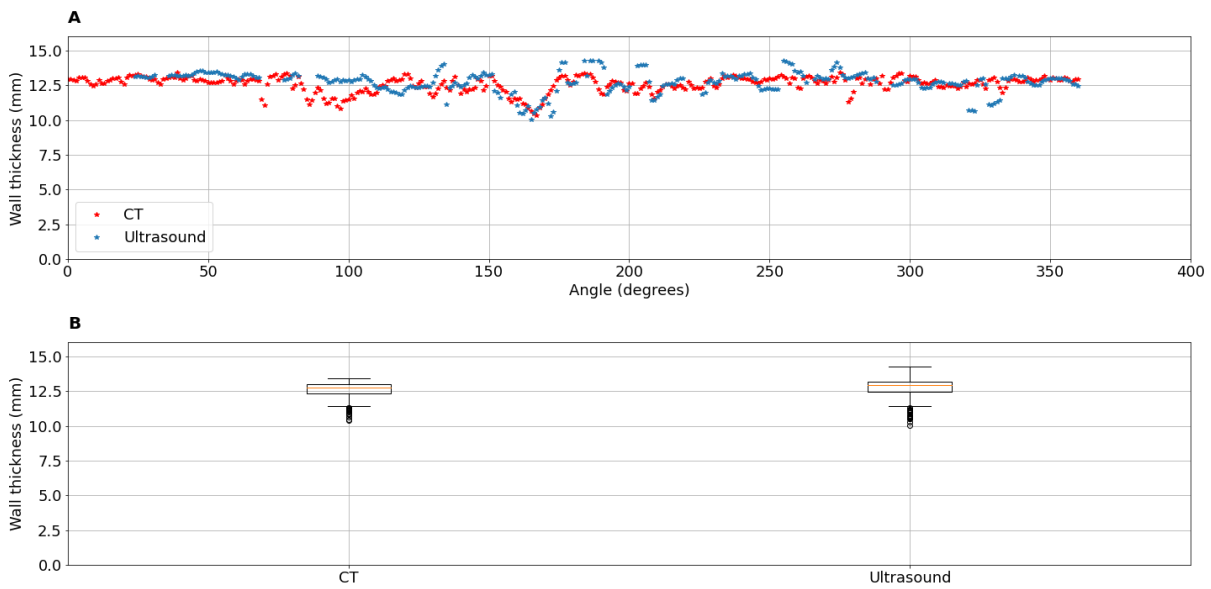
Figure 9 Sample 2, circumferential scan
